TesTex Off Surface Electromagnetic Technique (OSET) for Corrosion Under Insulation (CUI)

Off Surface Electromagnetic Technique: What Is OSET?

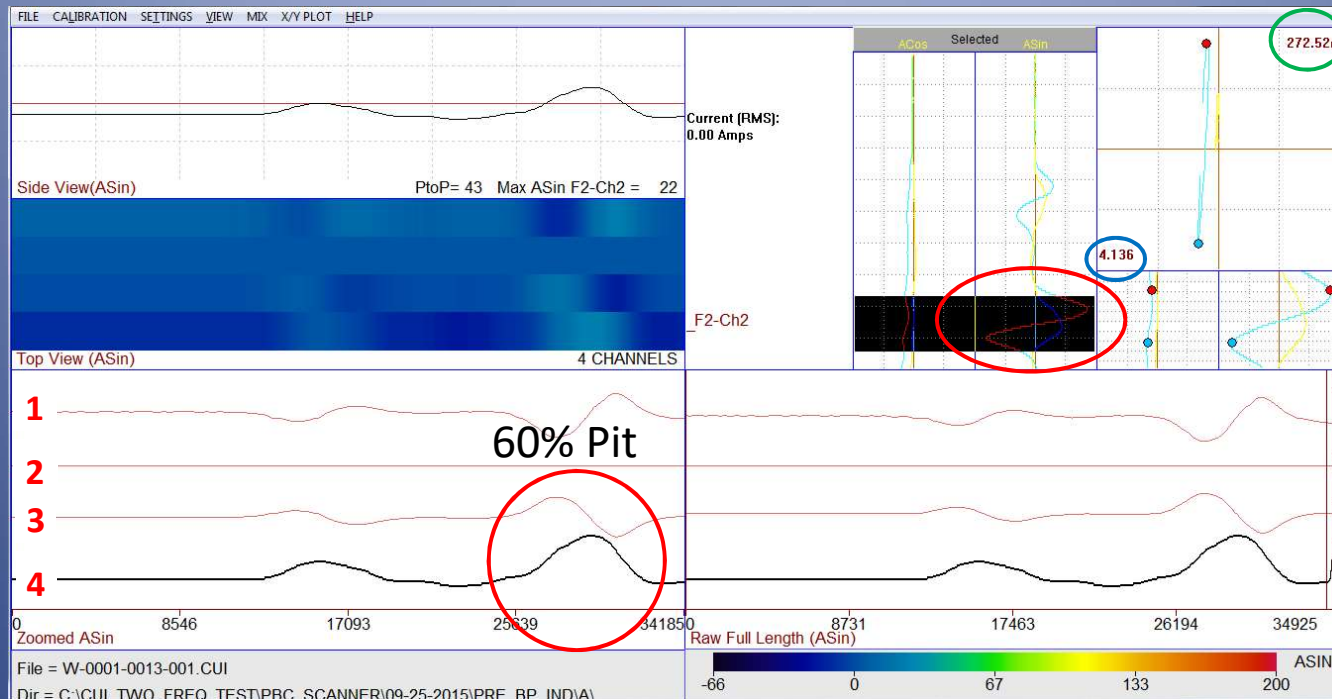
TesTex’s current CUI detection system uses a dual frequency system and generates four (4) responses, as shown in the bottom left panel above; 1.) High Frequency Differential; 2.) High Frequency Absolute; 3.) Low Frequency Differential; and 4.) Low Frequency Absolute. The type/shape of response (**red circles**), magnitude (voltage span, **blue circle**), and phase angle (**green circle**) can be analyzed to identify the type of anomaly (such as a weld, pitting, or general wall loss). The circled indication is for a 60% deep “ring” that was machined into the OD of the pipe to simulate wall loss.

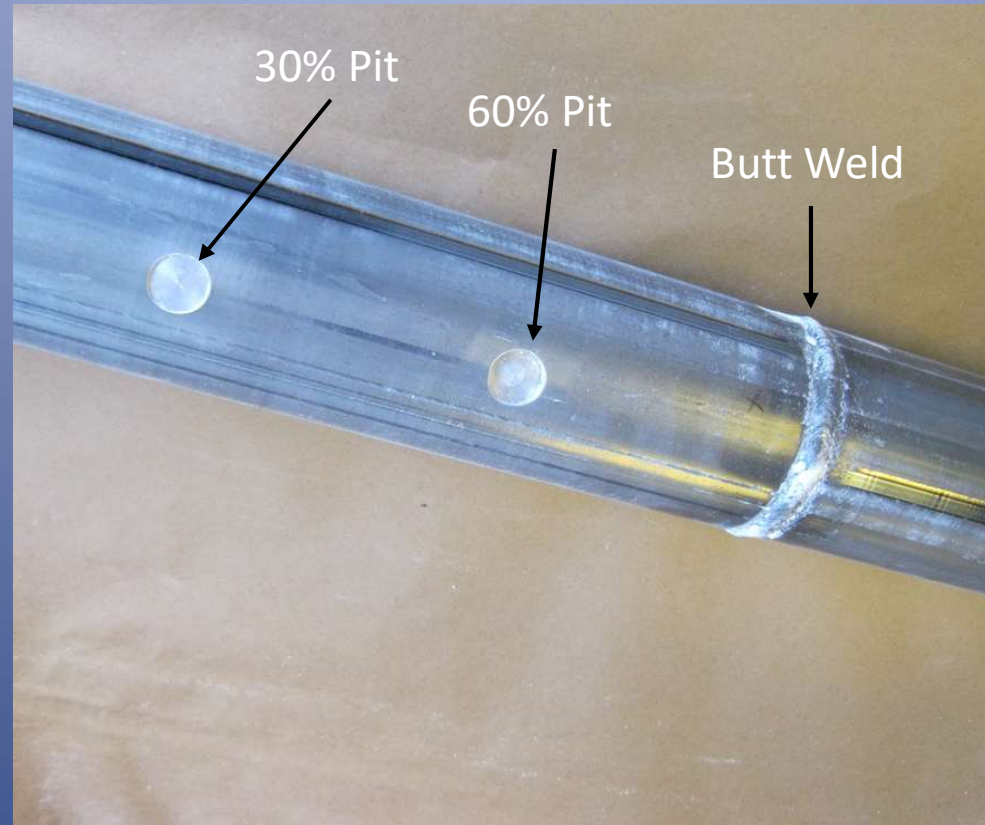
This picture shows a 4" schedule 40 carbon steel calibration pipe. From left to right on the pipe are a 30% deep pit, a 60% deep pit, and a butt weld. Calcium silicate insulation (2" thick) and an aluminum jacket were installed and the pipe was scanned with the OSET system, producing the wave form below.

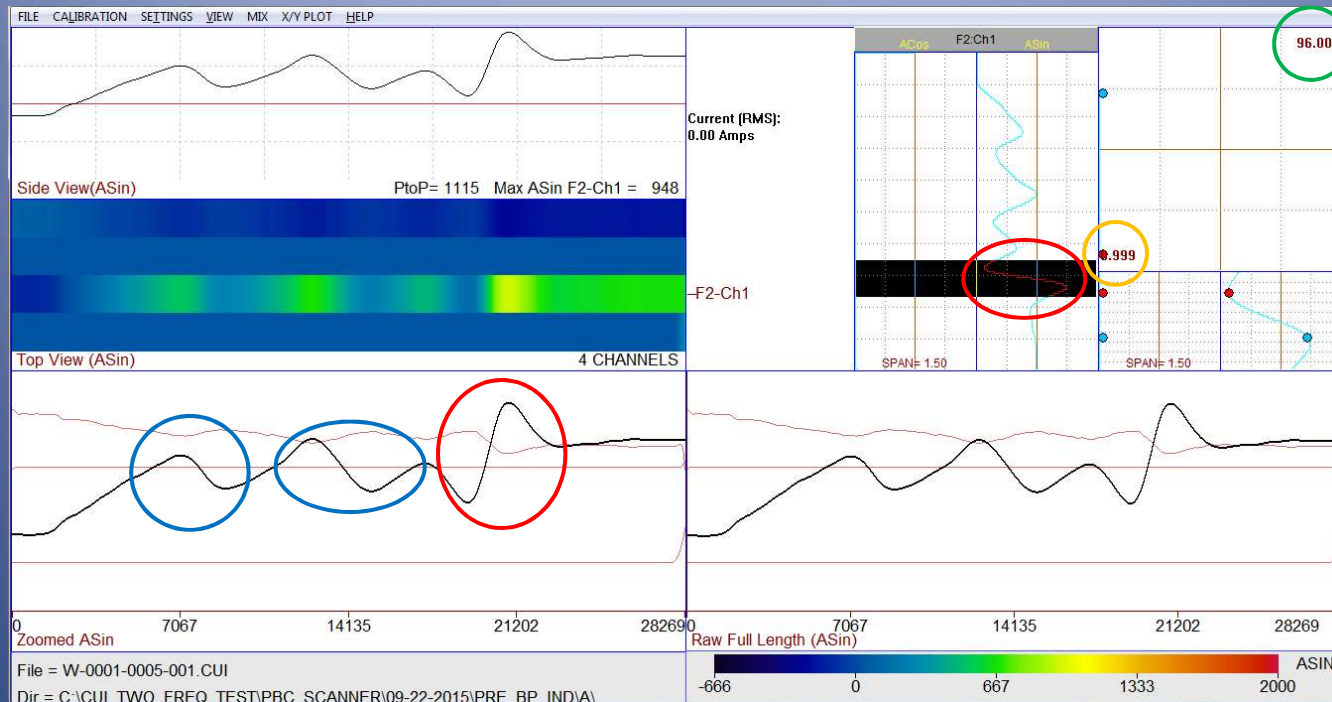
Indications of the two pits are circled in blue and the weld is circled in red. The weld signal is highlighted in the plot on the upper right of the screen (**red circle**), with a phase angle of 96° (**green circle**) and a voltage span of 0.999 (**orange circle**). (Note that the signal for the pits first rises above and then dips below the baseline, while the weld indication dips first and then rises.)

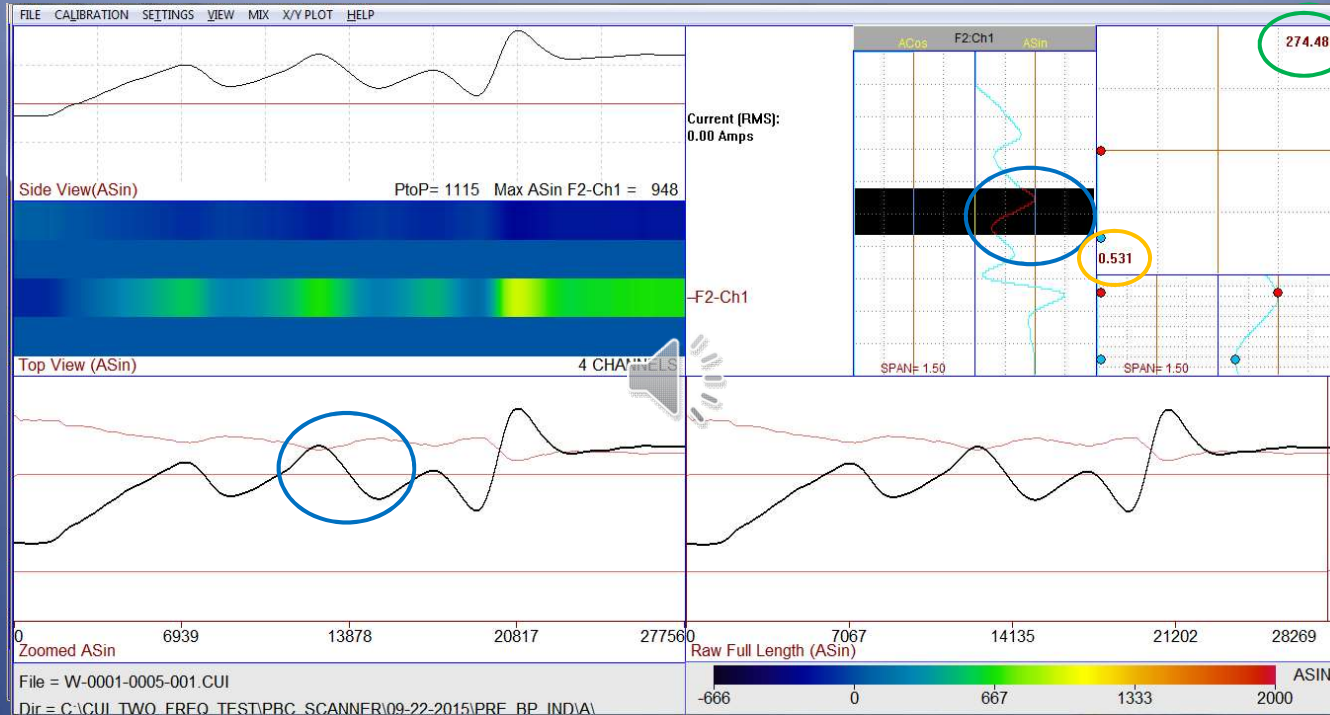
This is the same wave form with the 60% pit highlighted (blue circles). Note that the phase angle is about 274° , so approximately 180° from the weld angle. The 30% pit would show about the same phase angle and the voltage span would be somewhat less.

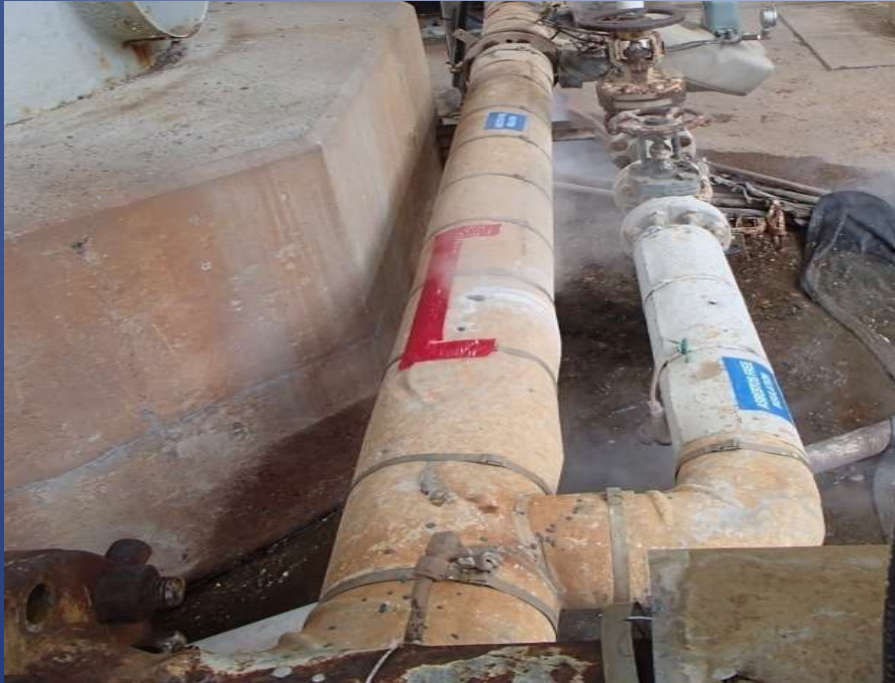
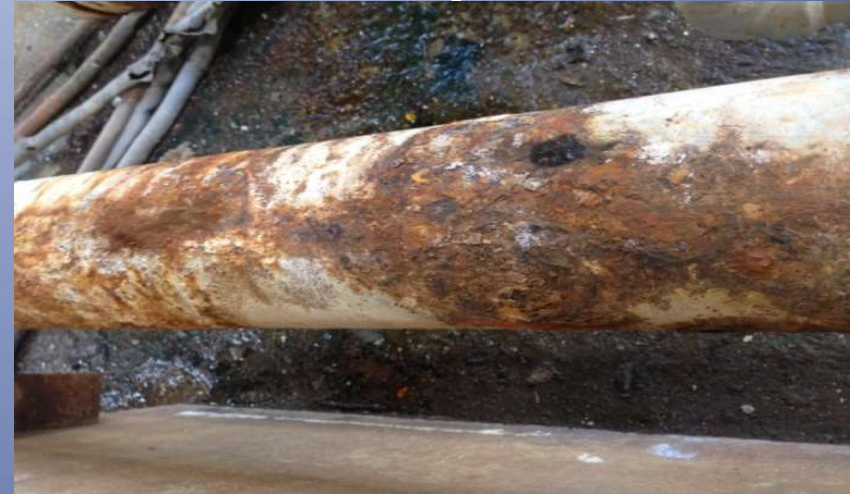
Braskem – Marcus Hook Inspection:

Pictures of a 4" pipe with suspected corrosion before & after the jacketing was removed. UT testing confirmed that there was 0.216" wall thickness remaining from nominal 0.240".

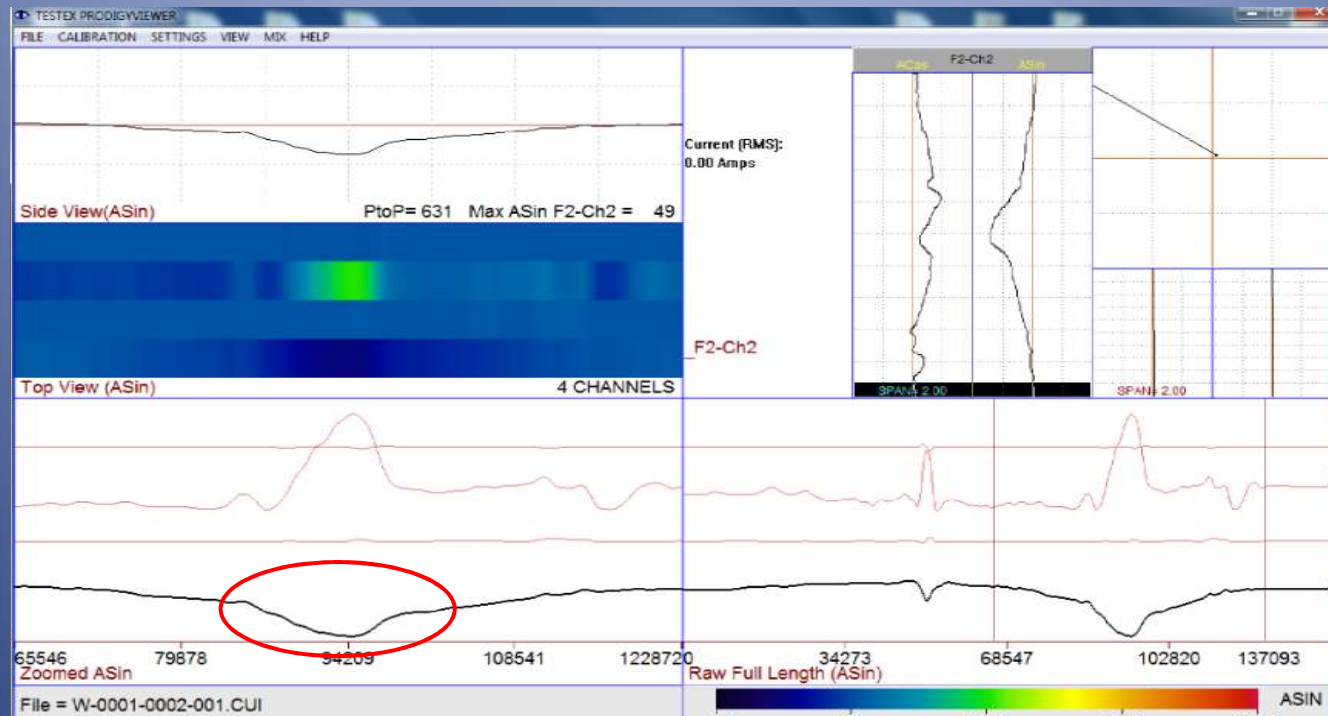
Braskem – Marcus Hook Inspection:

Wave form from the scan of the pipe above, with the low frequency absolute trace indicating wall loss (red circle). UT follow up determined that the wall thickness in this section of pipe ranged down to 0.216", vs nominal wall thickness of 0.240".

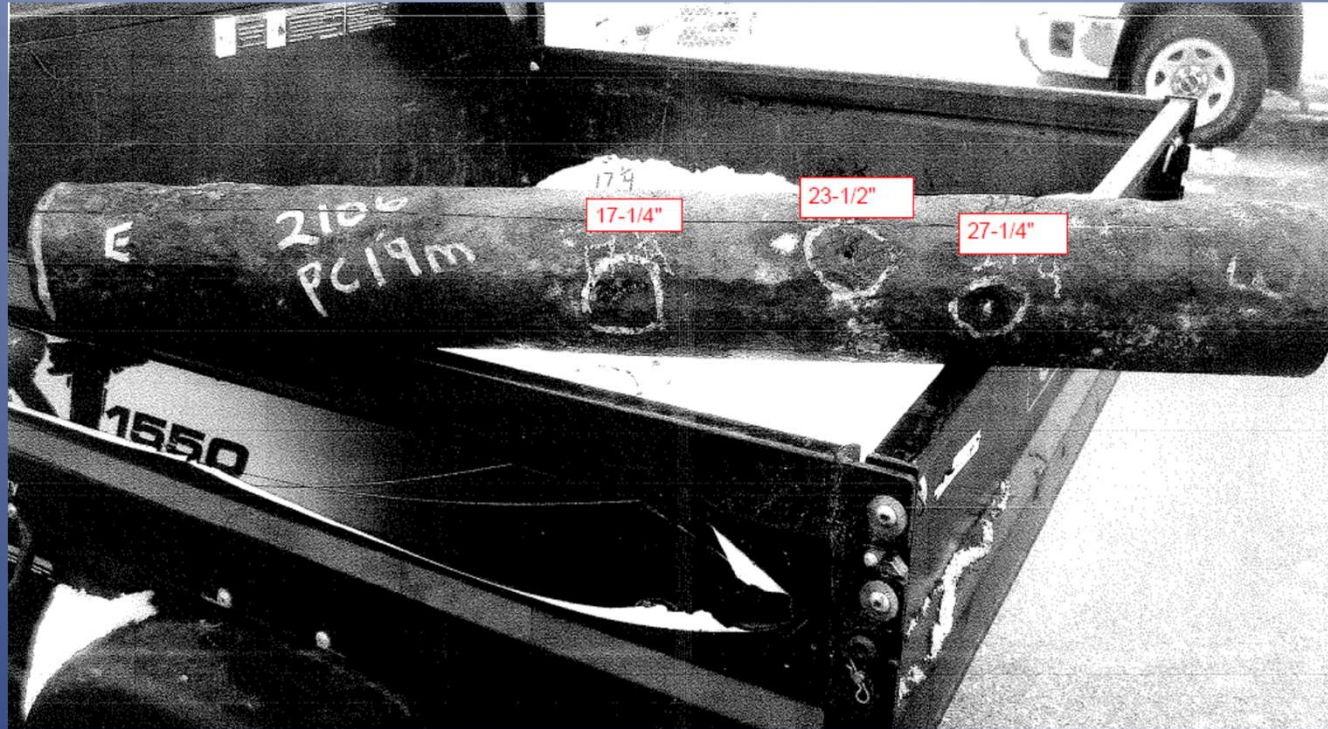
Marathon – Catlettsburg Test:

Picture of 4" naturally corroded test pipe that was removed from a process line at the refinery. In a blind test after new insulation and jacketing were installed, the OSET system detected the pitted areas that are circled, along with other flaws and general wall loss.

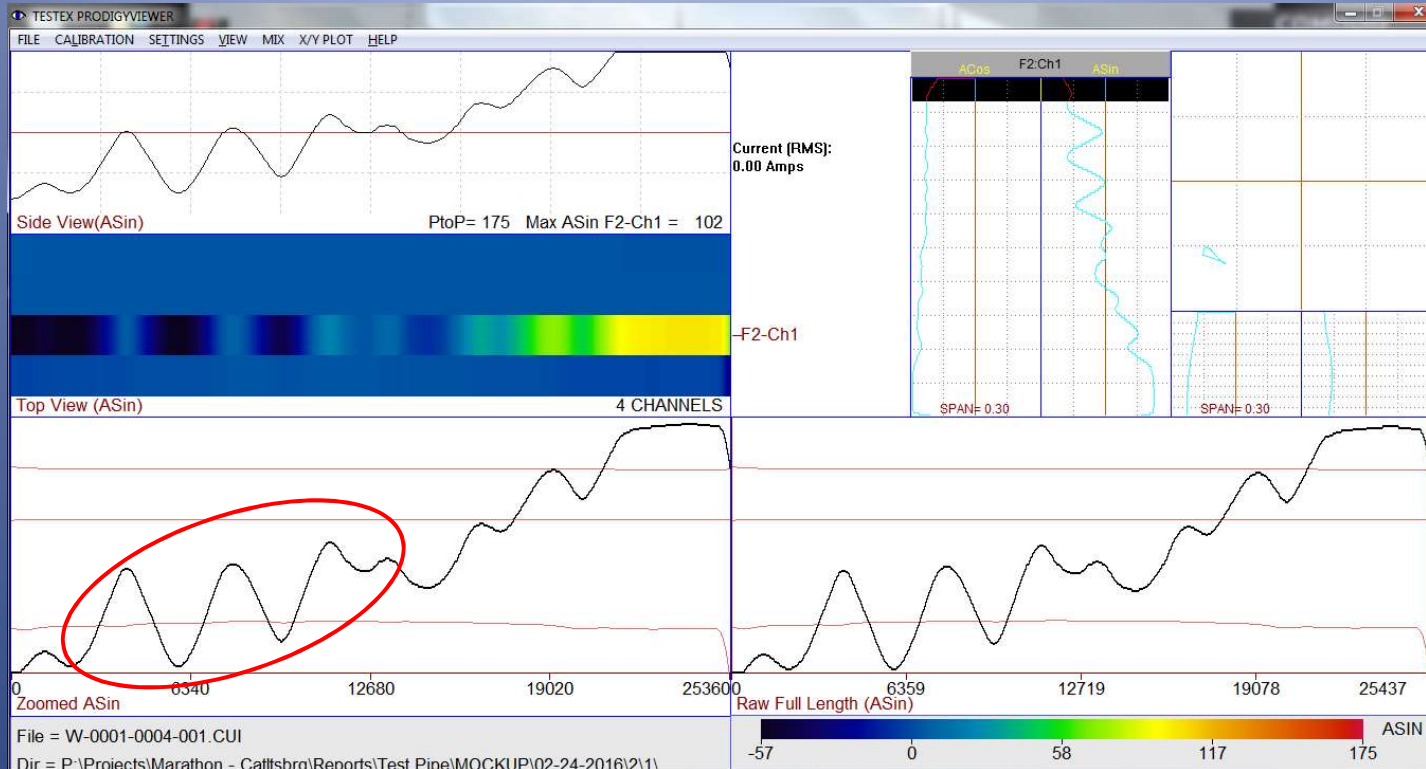
Marathon – Catlettsburg Test:

Wave form from the scan of the pipe above, with the low frequency differential trace indicating the three closely spaced pits (red circle) that are shown in the picture.

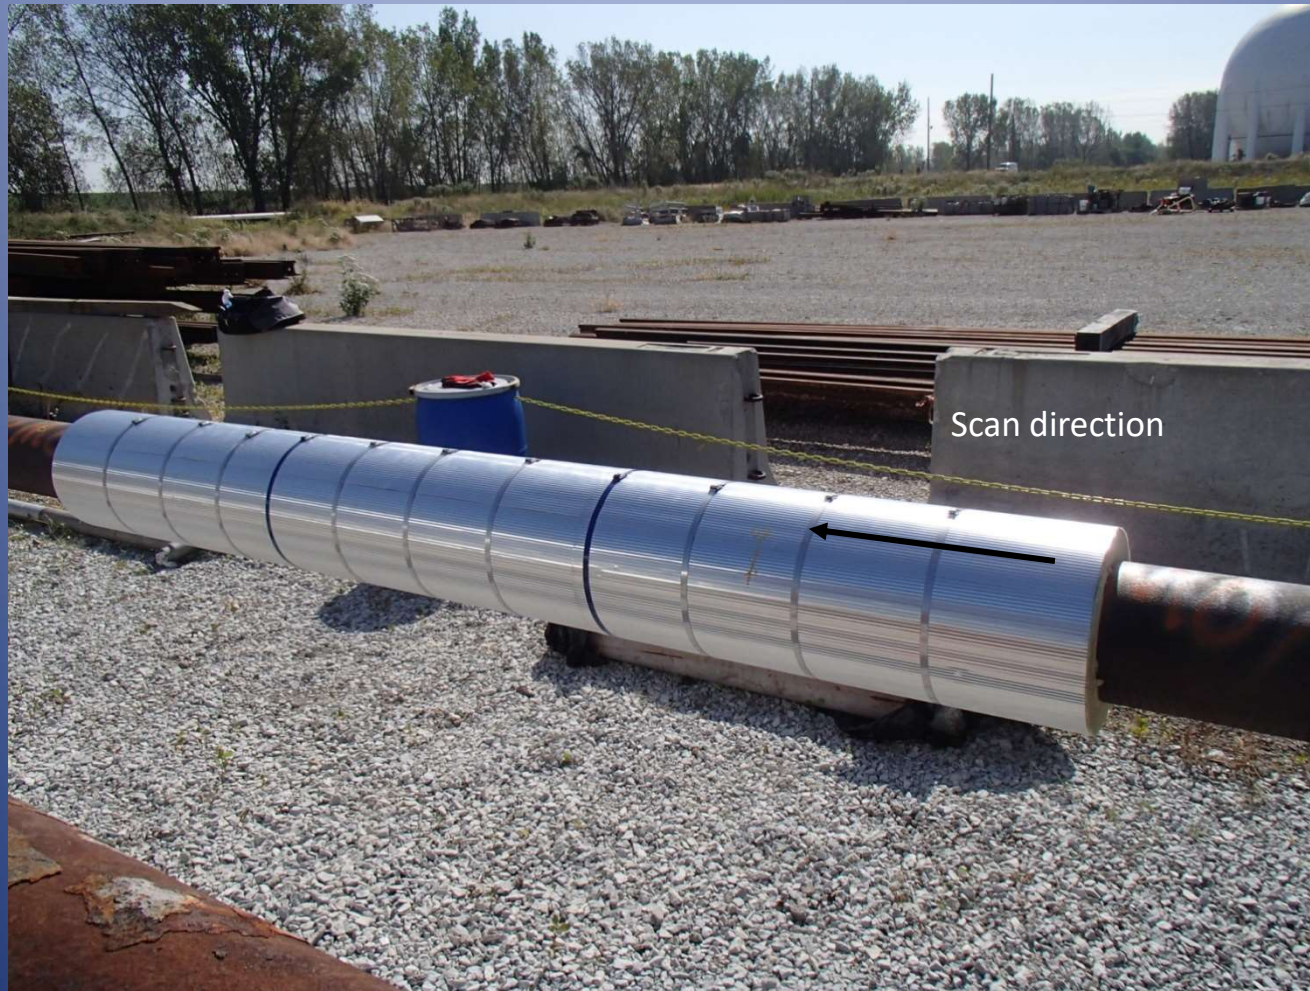
Picture of a pipe scanned as part of a test of the OSET technology. This was a pipe with natural corrosion that was removed from a process line.

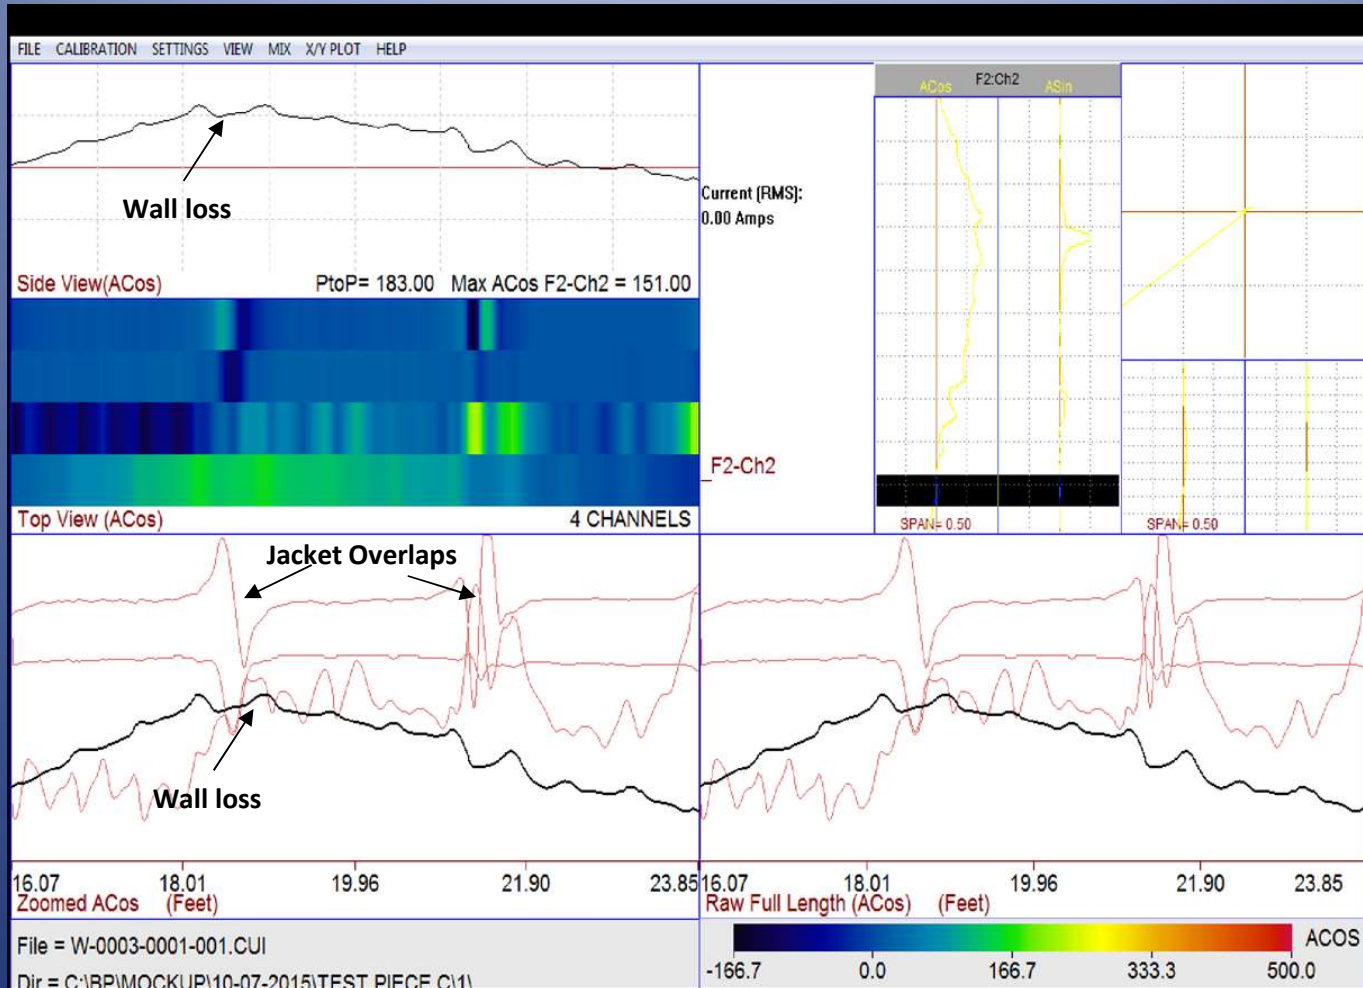
Wave form from the scan of the “3:00 O’clock” position of the pipe pictured in the previous slide. Note the fairly large deviation from the base line in the upper left section of the wave form, indicating the corrosion at the 3:00 O’clock position.

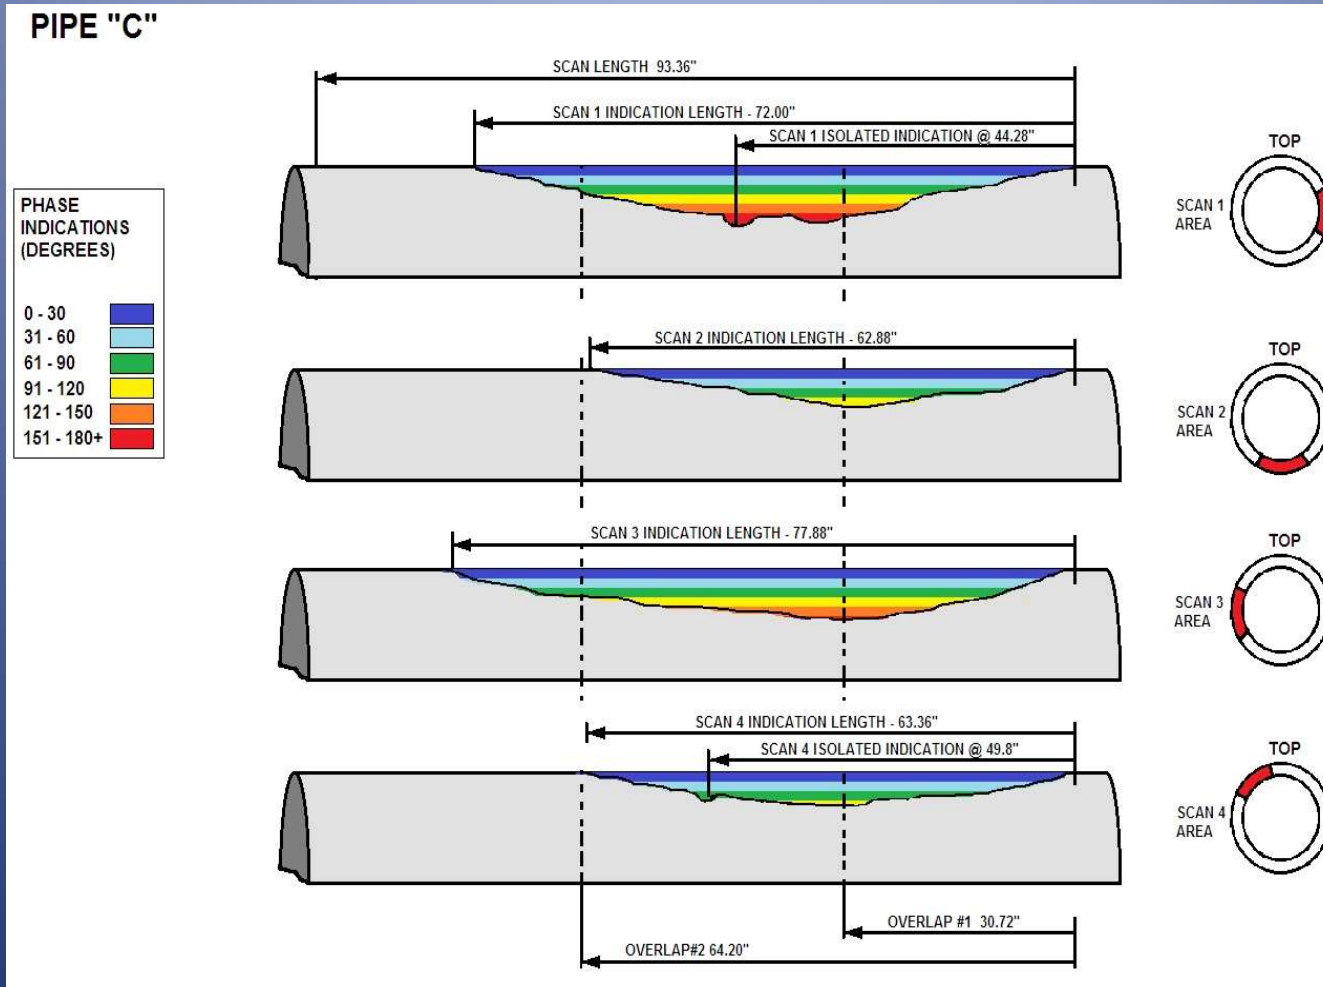
This is a representation of the scanned pipe showing wall loss at various scanned clock positions. Note that the corrosion is most extensive at the 3:00 O'clock and 9:00 O'clock positions.

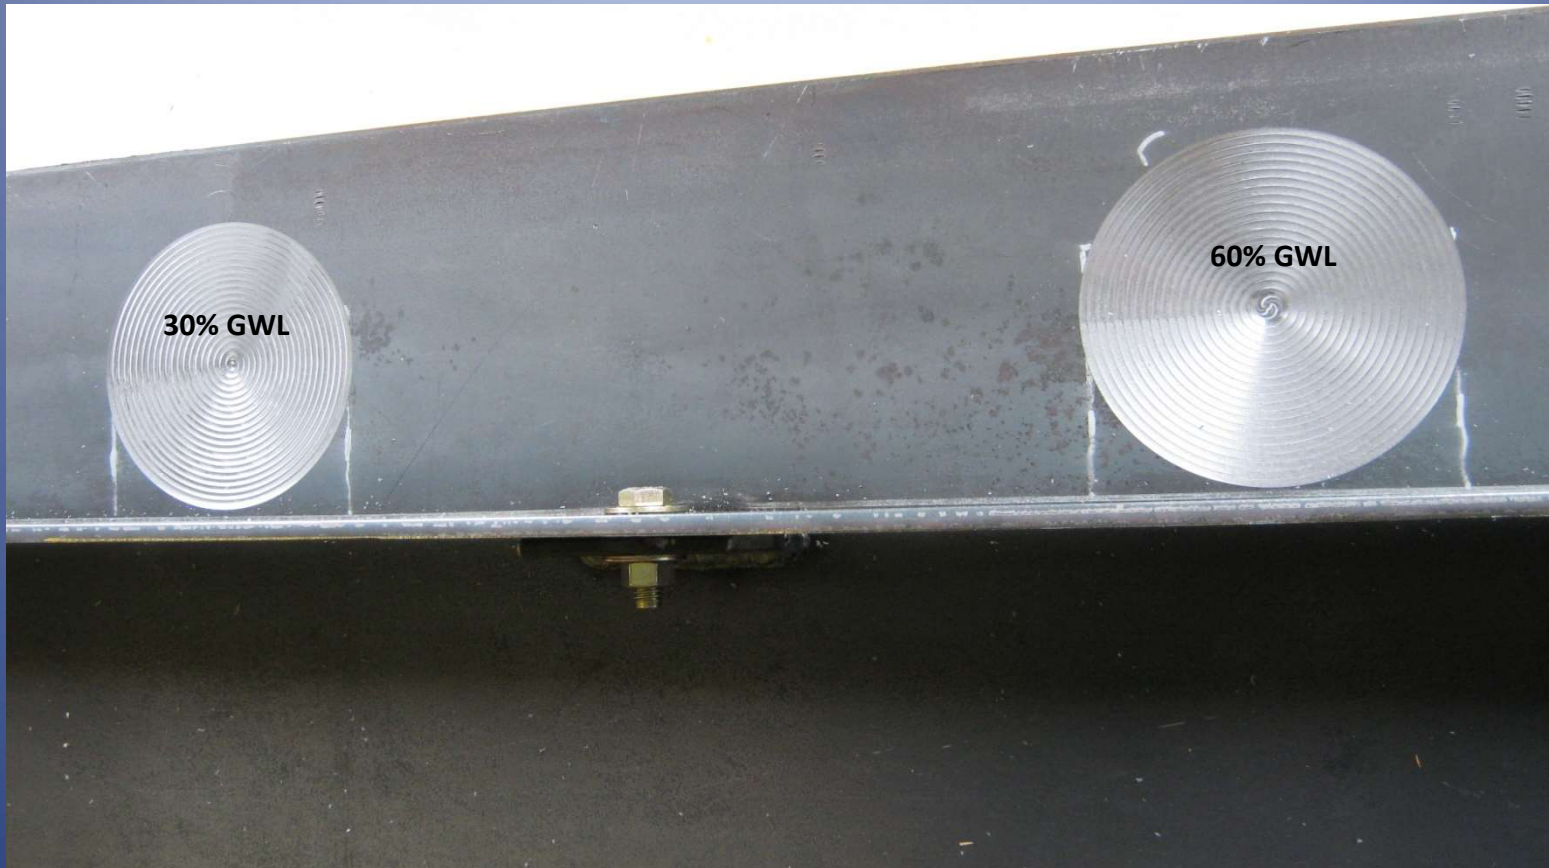
Marathon provided a 38" long x 12" wide by 1/2" thick plate with a 2-1/2" wide support ring to simulate a vessel wall. Testex had two tapered flaws machined into the surface, one 30% deep and the other 60% deep. The plate was then scanned under 3" of insulation and an aluminum jacket.

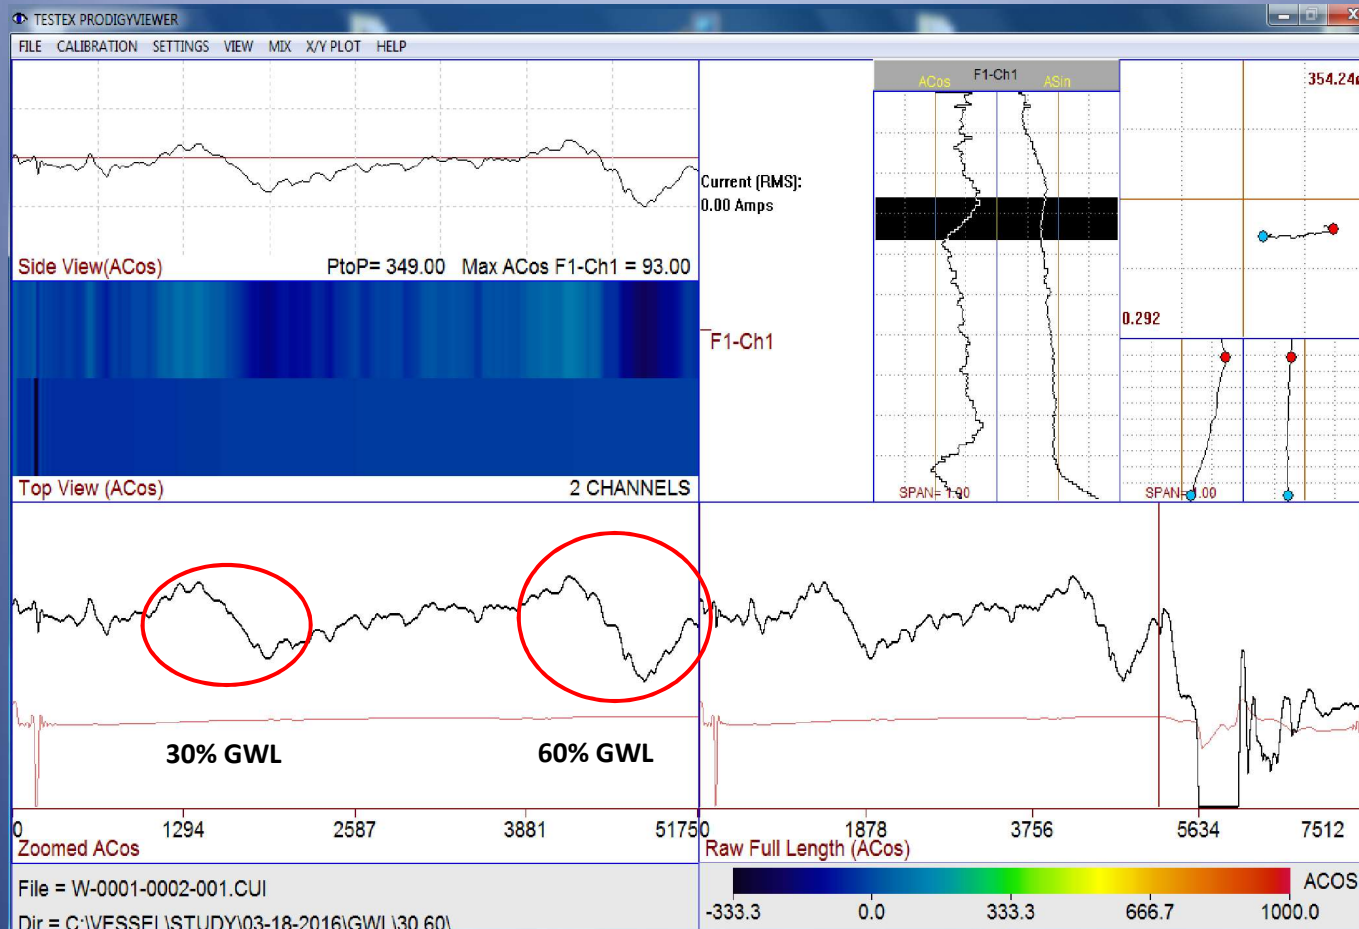
This wave form shows the response of the OSET system to the two (2) tapered circular flaws. As noted, the indication on the left shows the 30% GWL tapered flaw and the one on the right is the 60% GWL flaw.
